**SUBJECT: International® Vehicles with Steel Fuel Tanks**

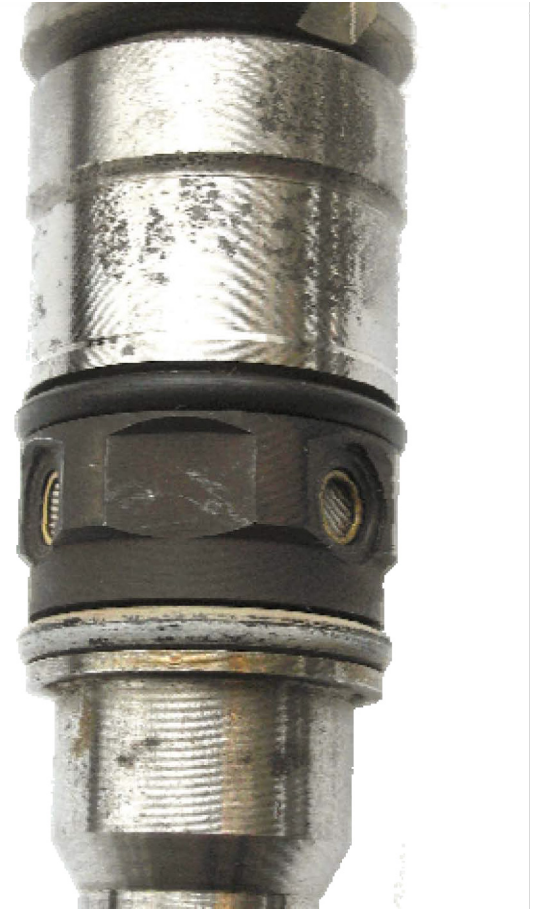
Some of the International vehicles equipped with VT365 engines listed below were sold with a steel fuel tank option. If you receive injectors or the vehicle for service with a complaint of an intermittent miss, check the injectors for traces of rust in the fuel (i.e., red or brown discoloration in the area between the two injector O-rings. Refer to the photo at right).

If rust is evident, it will likely be traced to corrosion of the steel fuel tank. At this time, International suggests replacing the steel tank with aluminum.

If a steel tank is determined to be the problem and the injectors show signs of rust, you're advised to replace all eight injectors.
