SUBJECT: 6.0 L Injector Stiction Discussion and Recommendations**6.0 L Injector Spool Valve Operation (refer to Figure 1)**

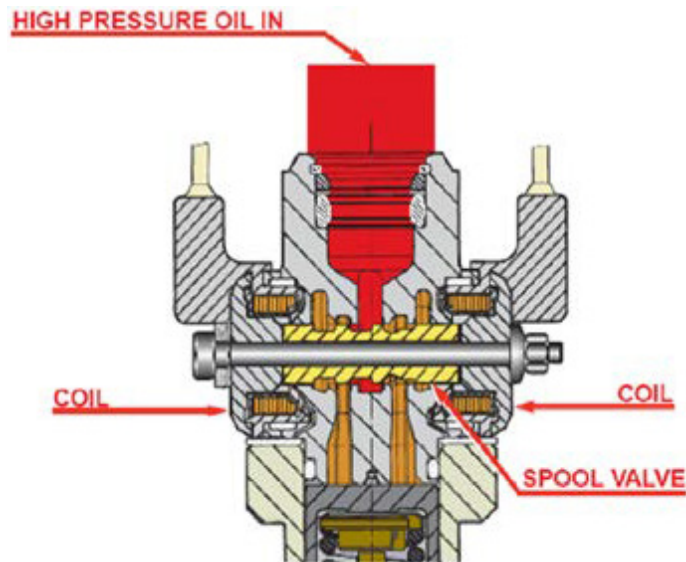
The spool valve is located in a bore in the stator housing; coils and coil housings positioned on both ends of the stator housing serve as end caps to seal the assembly and limit spool valve travel (0.432 mm). An open coil on one side of the stator housing and a closed coil on the other are alternately energized during engine operation to move the valve horizontally. The spool valve has two positions—movement of the valve over drillings in the stator housing which either (1) allow high-pressure oil from the oil rail into the injector high-pressure oil pumping chamber, or (2) allow pressure in the high-pressure oil chamber to collapse and oil to exhaust from the injector. Open coil energization allows high-pressure oil into the high-pressure oil pumping chamber; close coil energization allows oil to exhaust from the pumping chamber; when neither coil is energized, the valve will remain where it was last positioned (in Figure 1, below, the close coil is shown on the left side, and the spool valve is in the closed position; also note the gap between the spool valve and the open coil on the right side).

As applied to 6.0 L Injectors, the term is used to describe the condition when static friction (i.e., stiction), in addition to normal static inertia, is greater than the force of either injector coil, resulting in a delayed spool valve response or a stuck spool valve. Stiction can be either a momentary or permanent condition, but is most often momentary. Because the spool valve is operating in an engine oil environment, stiction is usually temperature related increased oil viscosity as a result of cold temperature will exacerbate stiction causing conditions, leading to an increase in stiction severity; decreasing oil viscosity as the engine warms up often leads to a decrease of cessation of stiction symptoms.

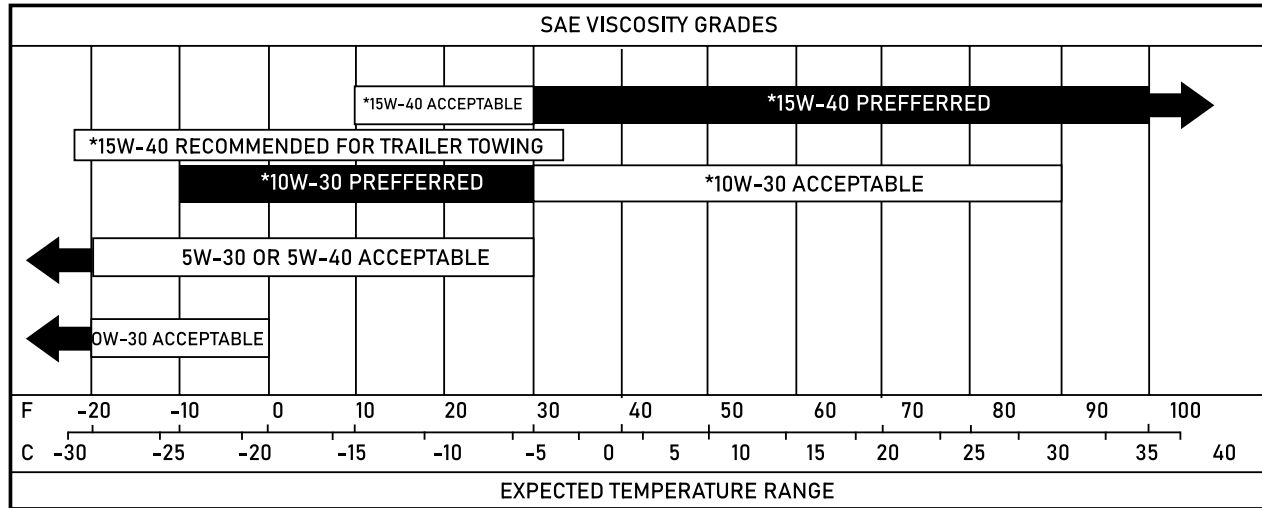
6.0 L DIESEL OIL GUIDE

1. Ensure engine oil is clean, is the correct viscosity for the temperatures it will be operating in (refer to Figure 2 on the next page) and has the recommended API service category rating (we advise using CJ-4 or CI-4 PLUS, although Ford allows CI-4).

6.0 L and 7.3 L Power Stroke® customers should be reminded to adhere religiously to Ford's minimum recommended lube oil and filter change intervals (7,500 miles normal duty; 5,000 miles severe duty).
