**SUBJECT: Fault and No Fault Injector Warranty Claims**

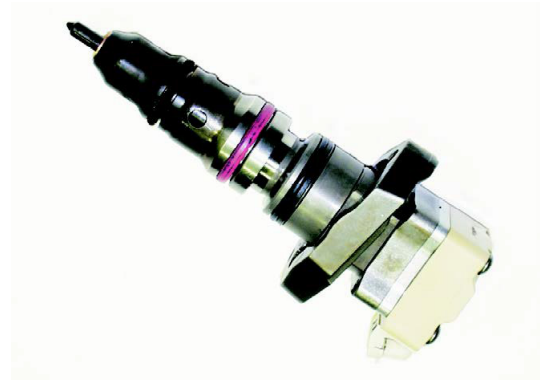
Almost one quarter of the claims in this category were found to be “chamber gasket not sealing” (see photo at right). Alliant Power Warranty Policy specifically excludes failures caused by “...improper application, installation or operation...,” and chamber gasket not sealing is an installation problem. Before installing Alliant Power Injectors in an engine, we recommend using solvent and a stiff brush (i.e., Rotunda/Owatonna Tool part number 303-D111) to loosen and remove carbon materials. Pay particular attention to the chamber gasket and injector O-ring sealing areas then use shop towels to clean and dry the sleeve.
