SUBJECT: IPR Valve External Damage During Installation

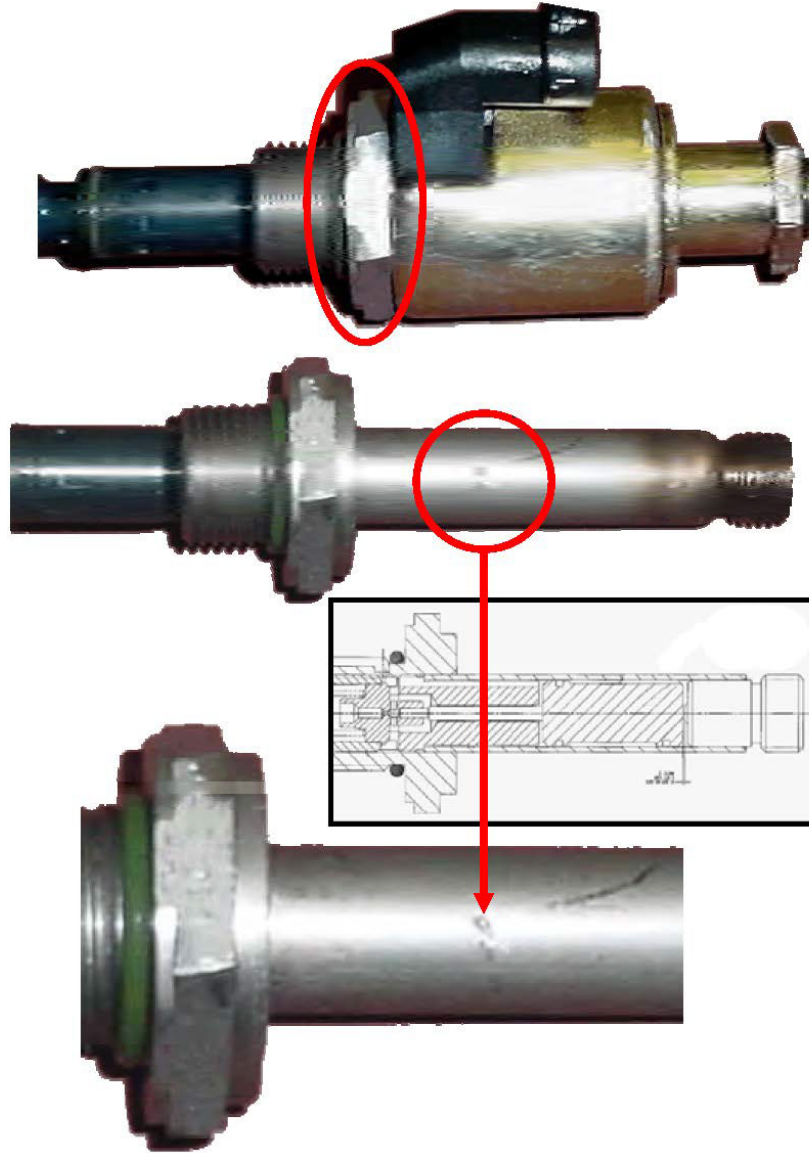
External damage to an IPR valve tube during installation can create enough internal distortion to prevent the armature from moving freely. In the photos above, note the damaged valve hex flats, which offer evidence the socket slipped and damaged the tube during installation. To avoid similar damage, we recommend using a six point deep well socket.

Valves determined to have this type of damage will not be considered for warranty:

- Armature tube assembly torque: 35 lb-ft
- Coil assembly torque: 53 lb-in
