**SUBJECT: 6.0L Injector Connector Configurations**

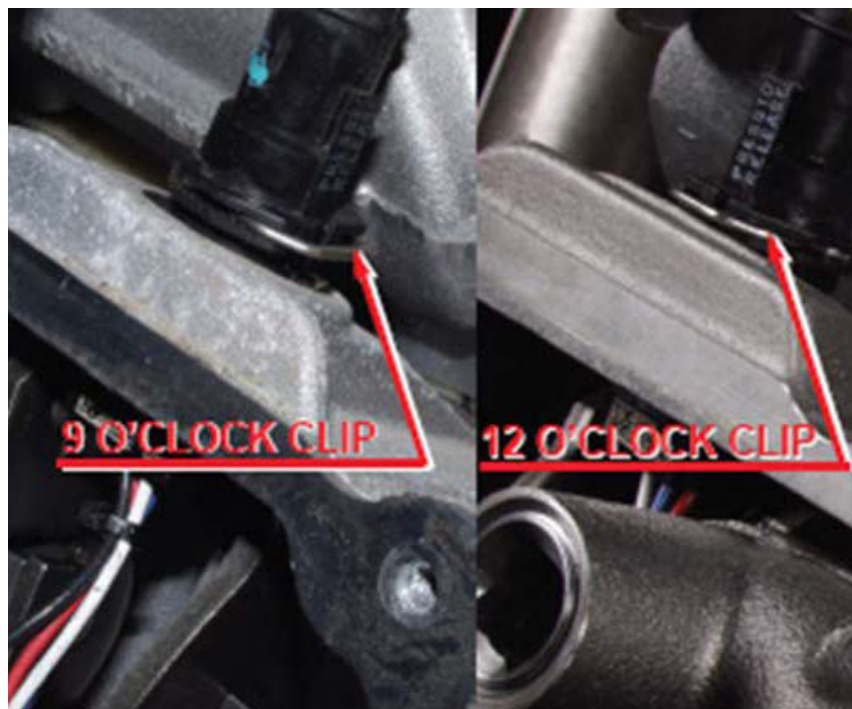
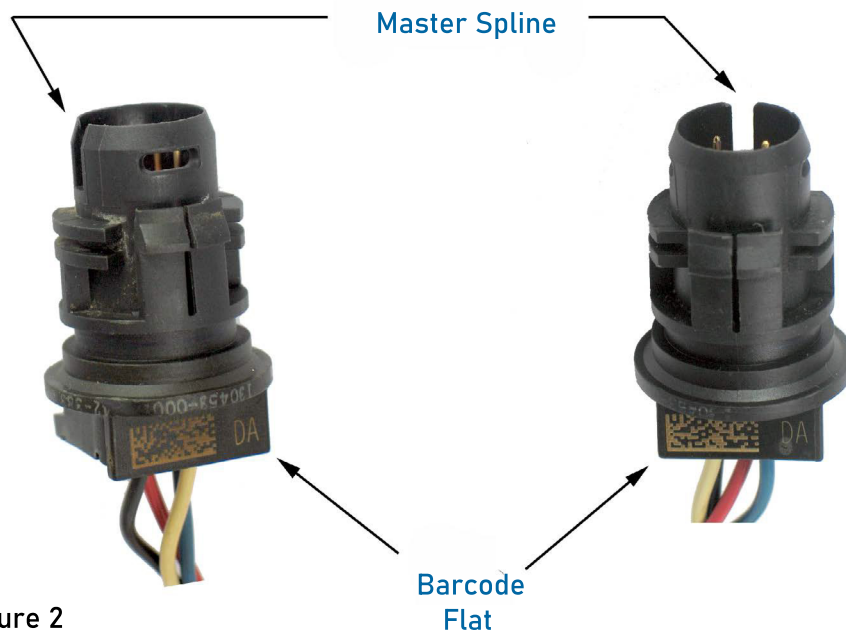
Figure 2

In conjunction with this change, the position of the barcode flat of the injector connector relative to the connector master spline was also changed. As shown in Figure 2, with injectors built prior to the running change, the master spline is at 9 o'clock when viewed from the barcode flat side. With injectors built after the running change, the master spline is at 12 o'clock when viewed from the barcode flat side. The position of the barcode flat relative to the master spline was changed to allow injector barcodes to be read easily during initial engine assembly. However, the barcode flat/master spline configuration has no effect on the operation of the injector.

Remanufactured injectors may have either connector. The installer should not expect all flats within a set to have the same orientation when installed in the engine.

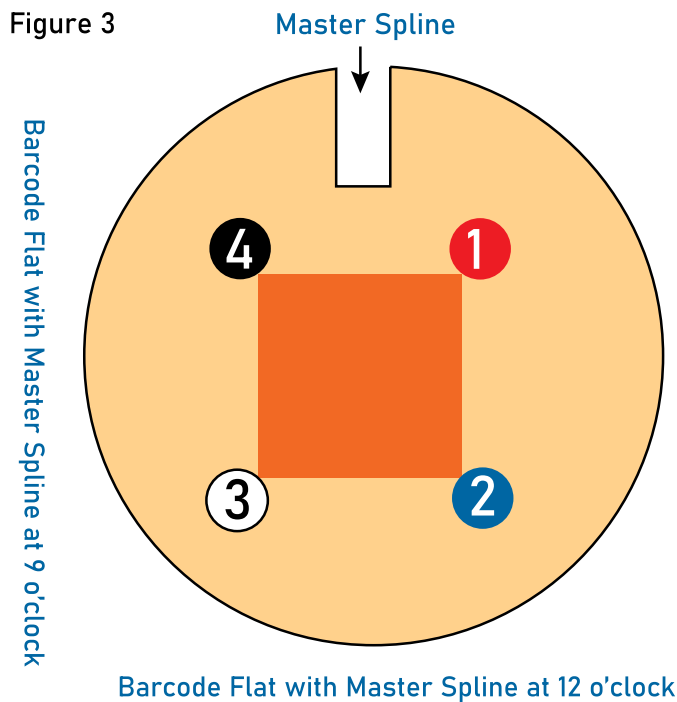
For reference, the line drawing (Figure 3) depicts the positions of the red (pin 1), blue (pin 2), white (pin 3) and black (pin 4) wires relative to connector pin numbers and the master spline. Note: The relationship of the pins and wires to the master spline remains constant regardless of the position of the barcode flat.
