NPA 05/12

SUBJECT: AP0059 Fuel Return Line Banjo Bolt

New Product Announcement

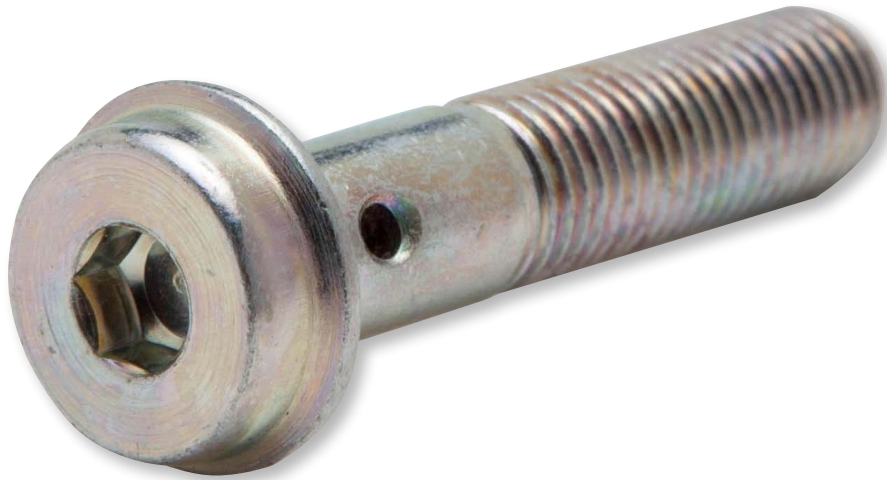
Alliant Power is pleased to announce the release of the **AP0059** Fuel Return Line Banjo Bolt for the 6.6 L LB7 Duramax[®]. Removal of the banjo bolts are required when servicing the fuel injectors. During the removal process, the hex drive is prone to damage which can make it difficult to torque properly during reassembly. Applying improper torque to the banjo bolt can lead to fuel leaks and crankcase dilution (fuel in oil). Alliant Power recommends replacing damaged banjo bolts to assure proper torque.
