TECHNICAL BULLETIN APTB 03/08 March 2008

SUBJECT: 6.0L Engine Stand Pipe and Snubber Valve Assemblies | R-1

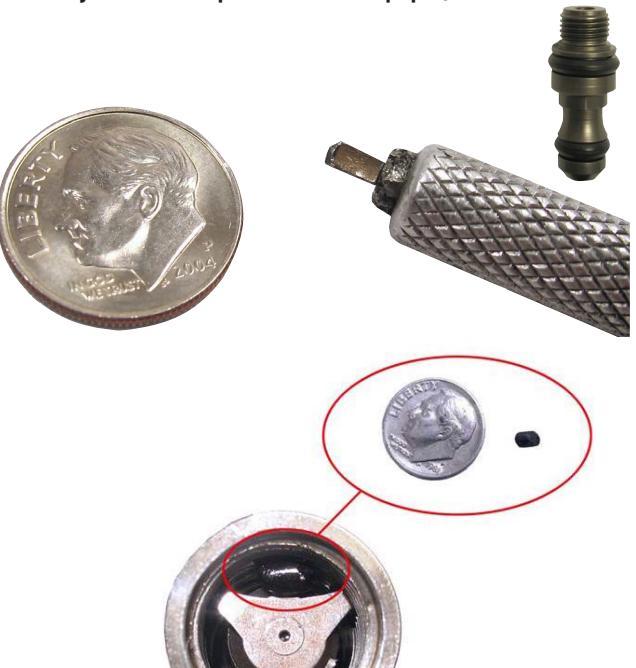
Debris in the snubber valve area can also lead to a driveability complaint. The non-ferrous piece shown in the photo at right (it appears to be a plastic fragment of the frame of the IPR valve screen or the high-pressure oil reservoir filter) was found in the snubber valve assembly of an engine that was being diagnosed for a flutter/vibration complaint on one bank. The position of the debris, wedged between the snubber plate and its bore, had no effect on the flow of the high-pressure oil inlet into the rail but prevented or reduced the snubber effect of the valve when ICP was reduced. Although no codes were present to lead the technician directly to this malfunction, in hindsight, we suspect the IPR duty cycle would show high variation at constant RPM.
