TECHNICAL BULLETIN APTB 03/04 ■ March 2004

SUBJECT: Priming To Prevent Nozzle Failures

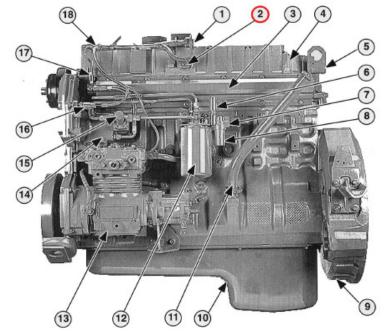
Injector Harness Component Location

The photos below provide detailed information for locating the injector harness on the valve cover

1. 31 - Pin Connector
Valve Cover Wiring Harness Connector
3. Supply Manifold
Valve Cover/Intake Manifold
5. Lifting Eye
6. Hand Primer Pump
7. Fuel Filter Header
8. Fuel Strainer
9. Flywheel Housing
10.0 il Pan
11. Oil Fill Tube and Oil Level Gauge
12. Fuel Filter
13.A ir Compressor (If Equipped)
14. High Pressure Oil Pump
15. Fuel Supply Pump
16. Engine Oil Temperature Sensor (EOT)
17. Injection Control Pressure Sensor (ICP)
18. Wiring Harness
