Combustion Blow-By Troubleshooting + Diagnostic Tips For Ford 6.0L Injectors

PRODUCT INFORMATION

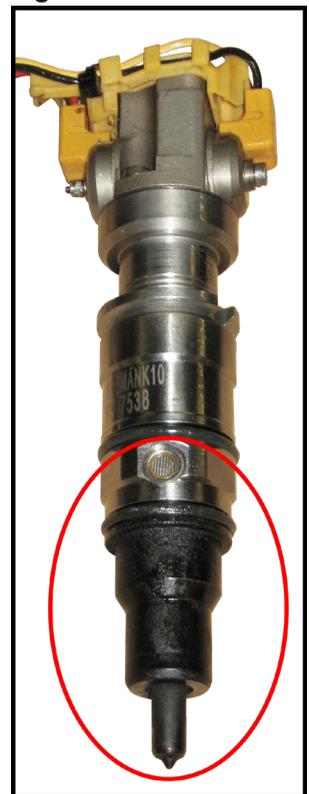
Figure A

A common problem on the 6.0L Power Stroke is air in the low-pressure fuel supply to the injectors. The majority of the time the cause is one or more injectors that are not properly sealing in the cylinder head. This allows combustion pressure in the cylinder to blow past the injector sealing washer and lower injector o-ring into the low-pressure fuel supply rail in the cylinder head.

Just one injector with combustion blow-by (see Figure A) will cause multiple misfires, usually on one bank and inaccurate power balance test results that can lead to unnecessary replacement of multiple injectors.

1. Not cleaning carbon deposits from the bottom of the each injector sleeve bore.
2. Missing or multiple injector sealing washer(s).
3. Reuse of the injector sealing washer. Once a washer is crushed during the injector installation, it will not provide another proper seal if the injector clamp is loosened or removed.
4. Either low or high torque of the injector clamp retaining bolt. Torque a retaining bolt requiring a T40 Torx bit to 24 lb. ft. (33 Nm) and a bolt requiring a T45 Torx bit to 26 lb. ft. (35 Nm).
5. Oil in the retaining bolt hole in the cylinder head or a stretched retaining bolt will allow the proper bolt torque to be made, however the injector will not be adequately retained in the cylinder head.

Low fuel supply pressure and air in the fuel supply system may affect the return stroke of the injector's intensifier piston leading to internal injector damage. Damage may occur to the injector with combustion blow-by and other multiple injectors on either cylinder bank. Prior to replacing multiple injectors, replace the injector(s) with combustion blow-by and reevaluate the engine operation.
